# UNDERWATER FACILITIES INSPECTIONS & ASSESSMENTS

NAVAL AMPHIBIOUS BASE  
CORONADO, CALIFORNIA

FPO-1-84(20)

NOVEMBER 1984

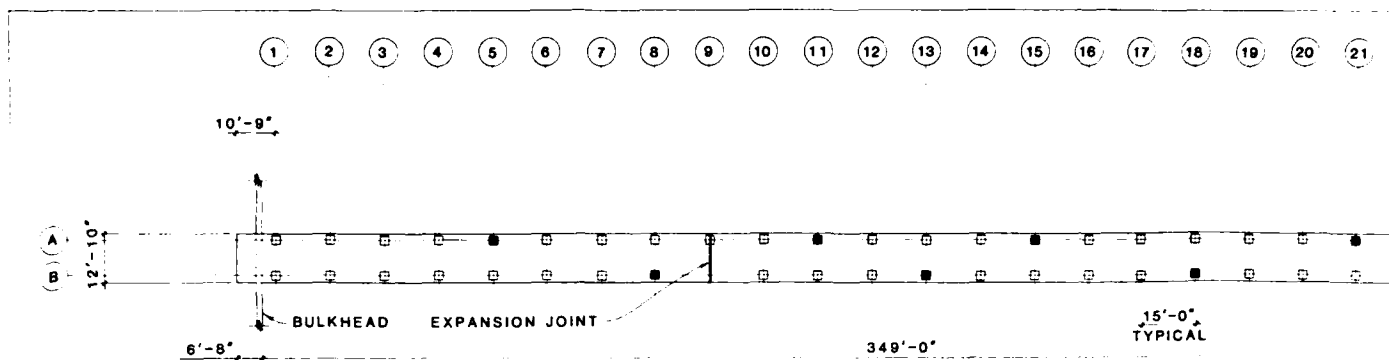
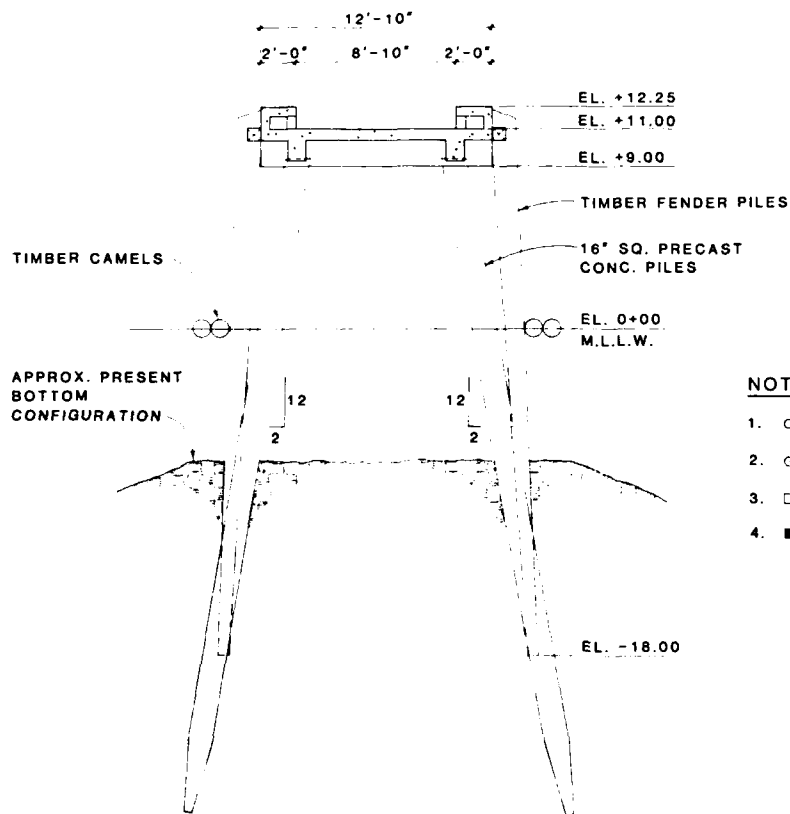
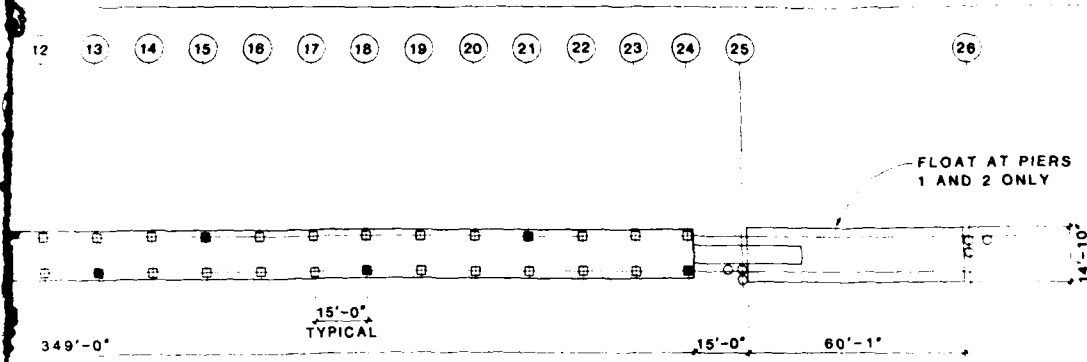
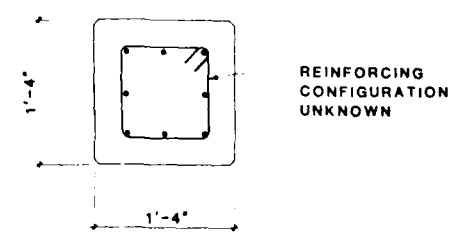
<b>PIERS 1 THROUGH 15</b> <b>PLAN AND TYPICAL SECTIONS</b> NAVAL AMPHIBIOUS BASE, CORONADO, CALIFORNIA		
Blaylock-Willis and Associates STRUCTURAL ENGINEERS    SAN DIEGO, CALIFORNIA	DATE: NOV. 1984	<b>FIG. 6</b>

2. Piers 1-15 and Bridge - The inspected portions of these facilities are considered to be in satisfactory structural condition. In general, the comments applying to Fuel Pier apply to Piers 1 through 15 and Bridge.

The sulphate damage found is of minor nature and does not significantly reduce the piles structural capacity.

It is recommended that the piles be inspected again in six years.

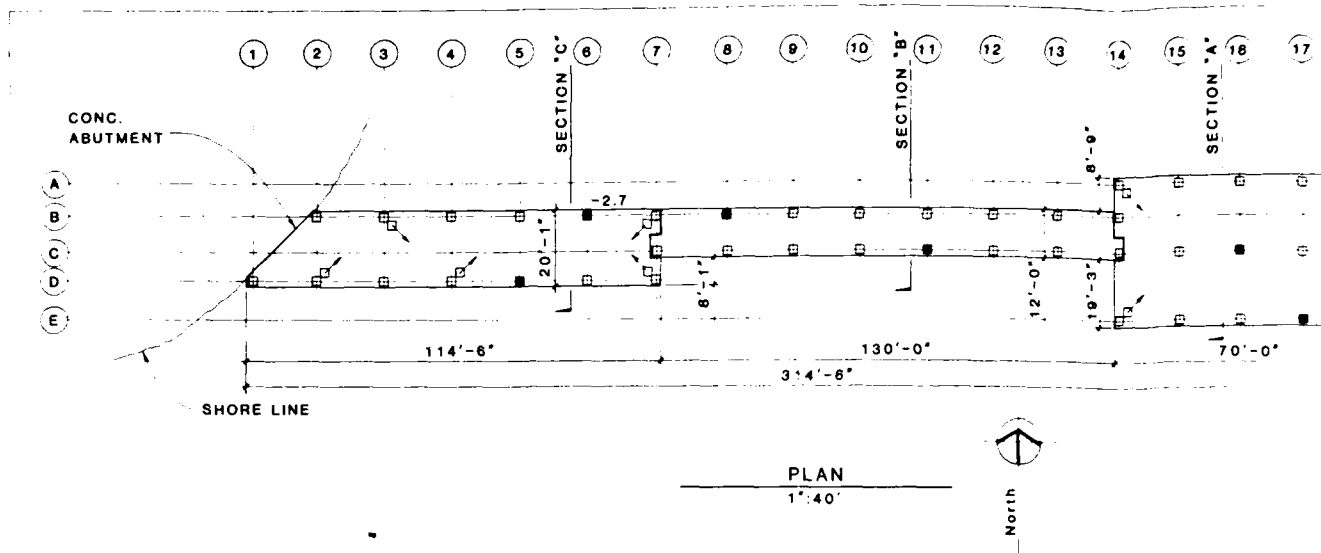
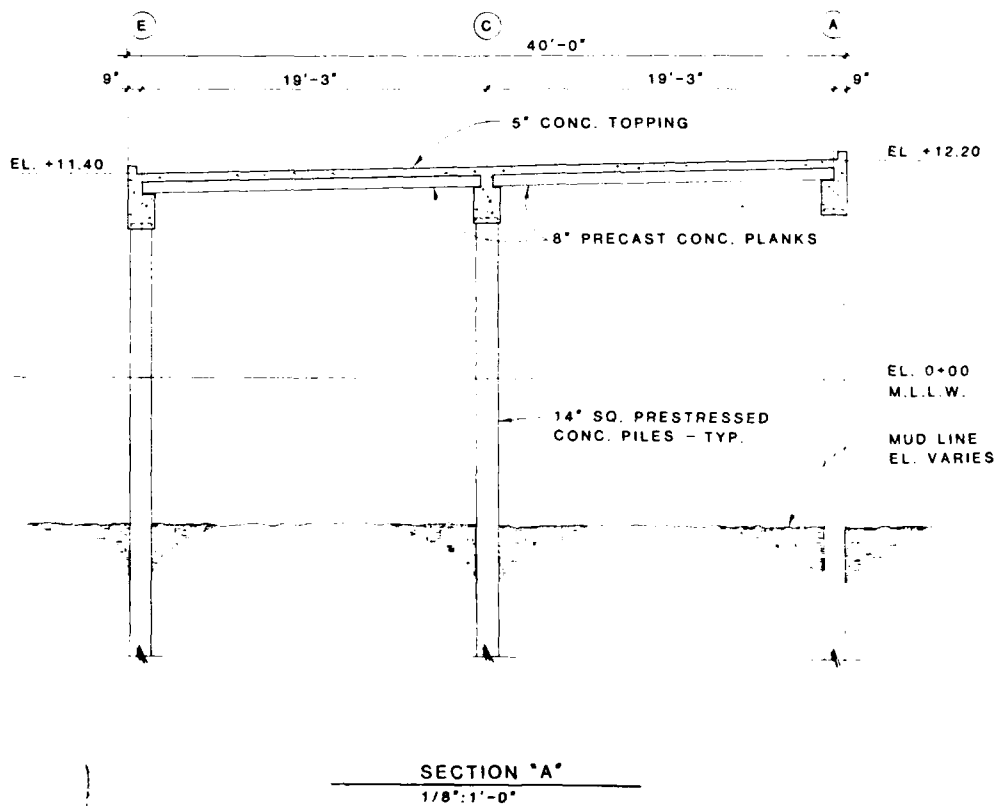
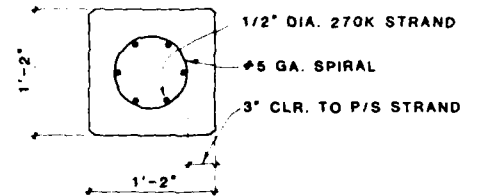
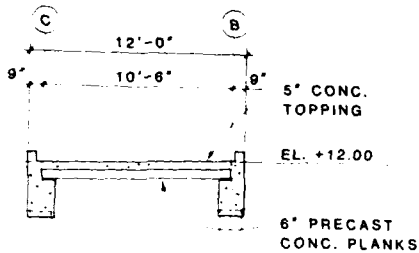
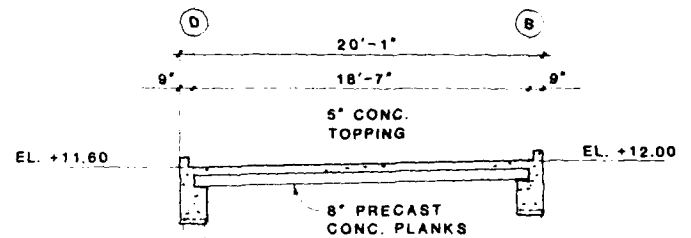
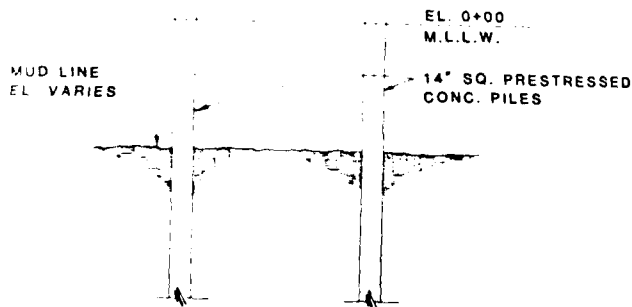
3. Mammal Pier - The supporting structural piles of the Mammal Pier are in excellent condition. However, considerable damage has been sustained by the pile cap beams. It appears that both the beams' stirrups and bottom principal reinforcement are rusting resulting in cracking and spalling of the covering concrete. The inspection team was informed that the outer plat-

It is recommended that the problem of rusting reinforcing with consequent cracking and spalling of the cap beams be addressed by a repair contract. It is further recommended that the Pier be inspected in six years.

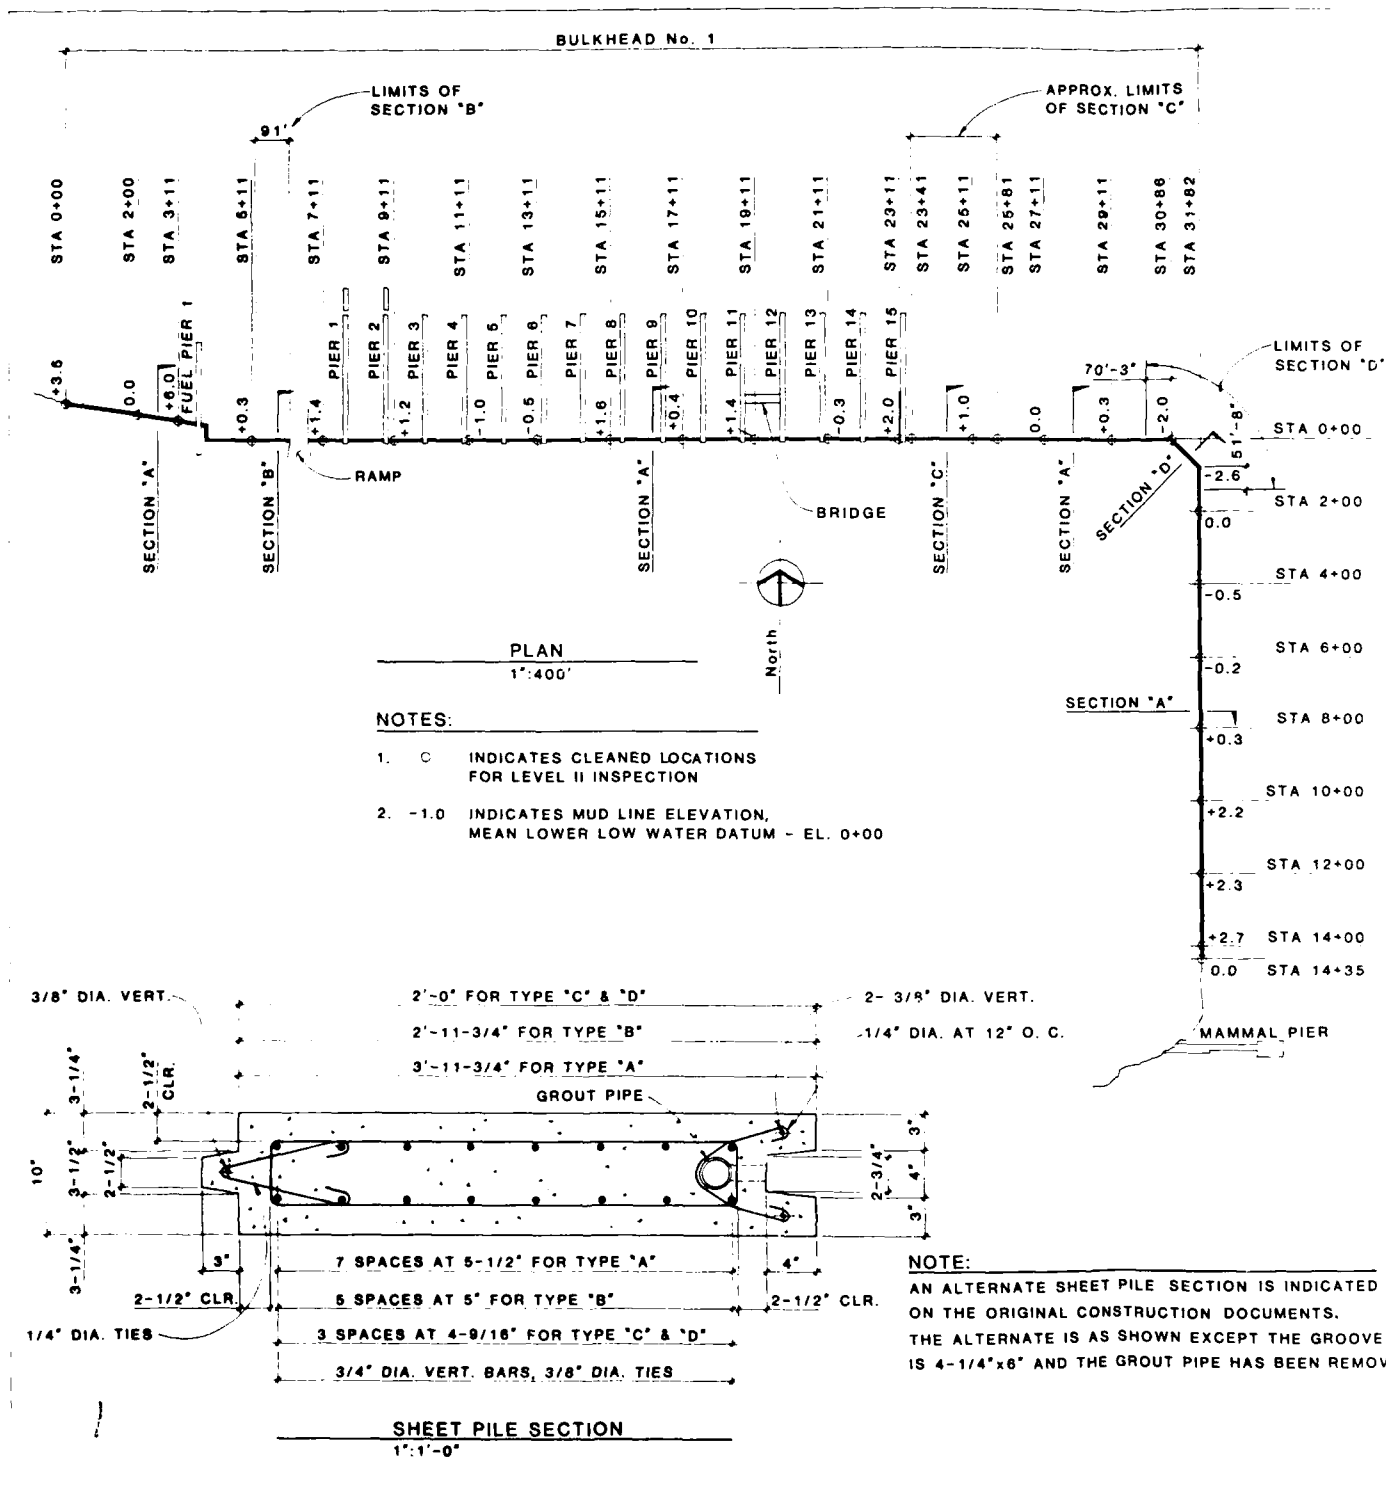
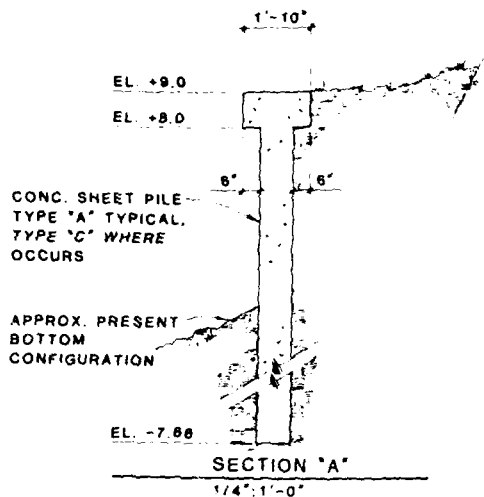
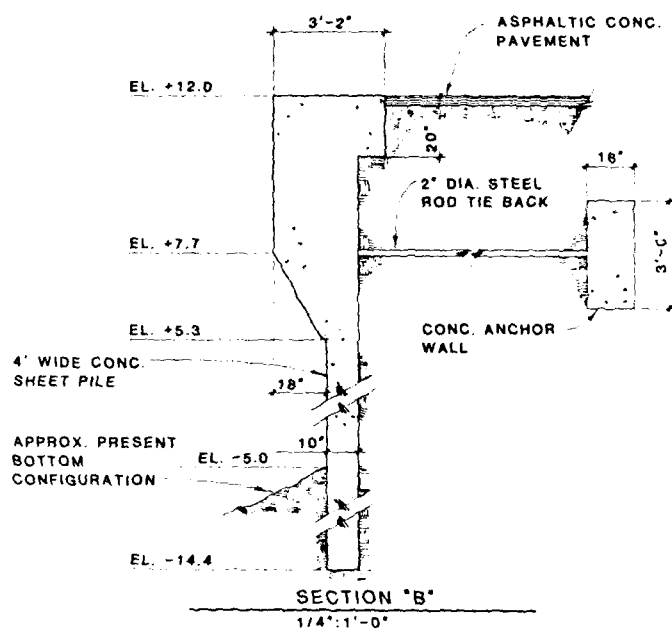
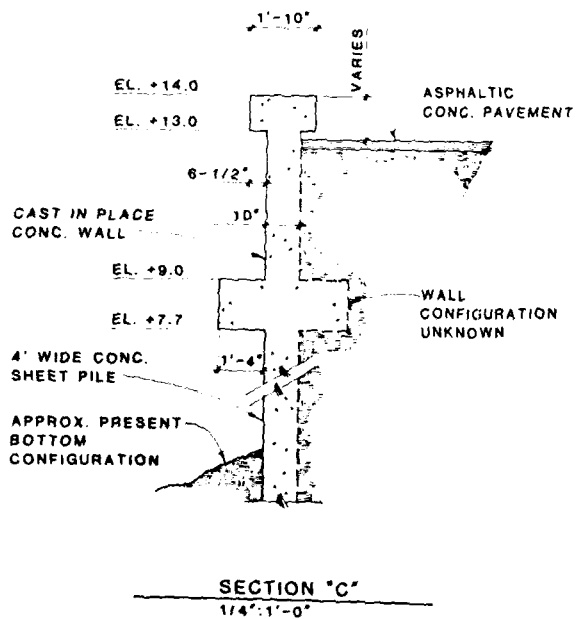
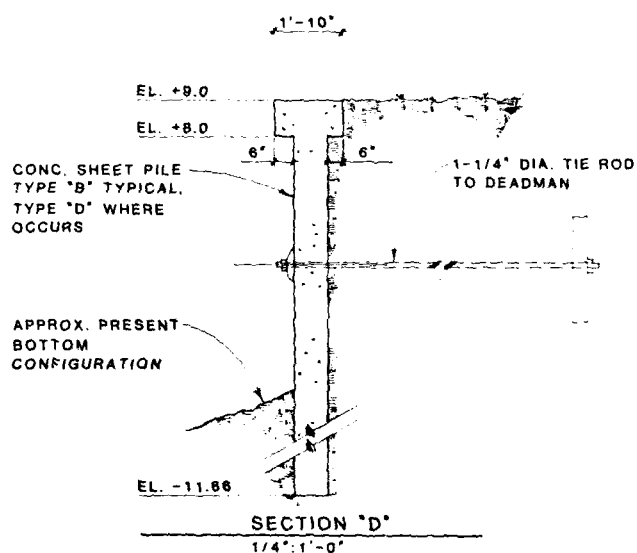
# **BULKHEADS** **PLAN AND TYPICAL SECTIONS** NAVAL AMPHIBIOUS BASE, CORONADO, CALIFORNIA

Fr P i  
4. Bulkheads 1 and 2, <sup>and</sup> - The Bulkheads are in generally good condition. There is some evidence of rusting horizontal reinforcement at the cap with accompanying cracking and spalling and there is some evidence of rusting of reinforcement in the wall panels. There is evidence of past gunite repair of this type of damage at various locations in the wall. It is recommended that continued attention be addressed to repair of severe spalling when it occurs.

It is recommended that continued attention be addressed to the repair of severe spalls when they occur to the Bulkheads and the Bulkheads be inspected again in six years.

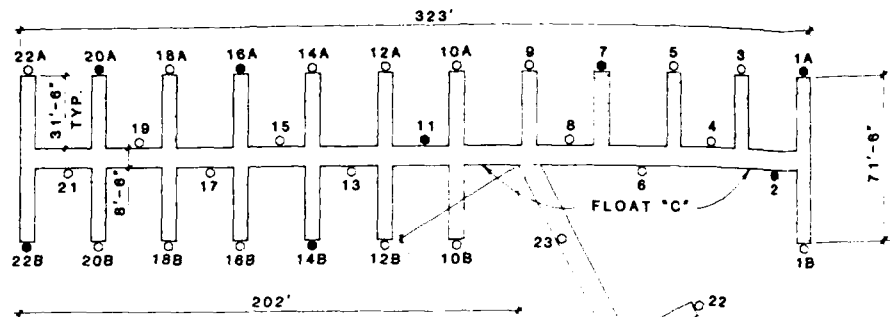
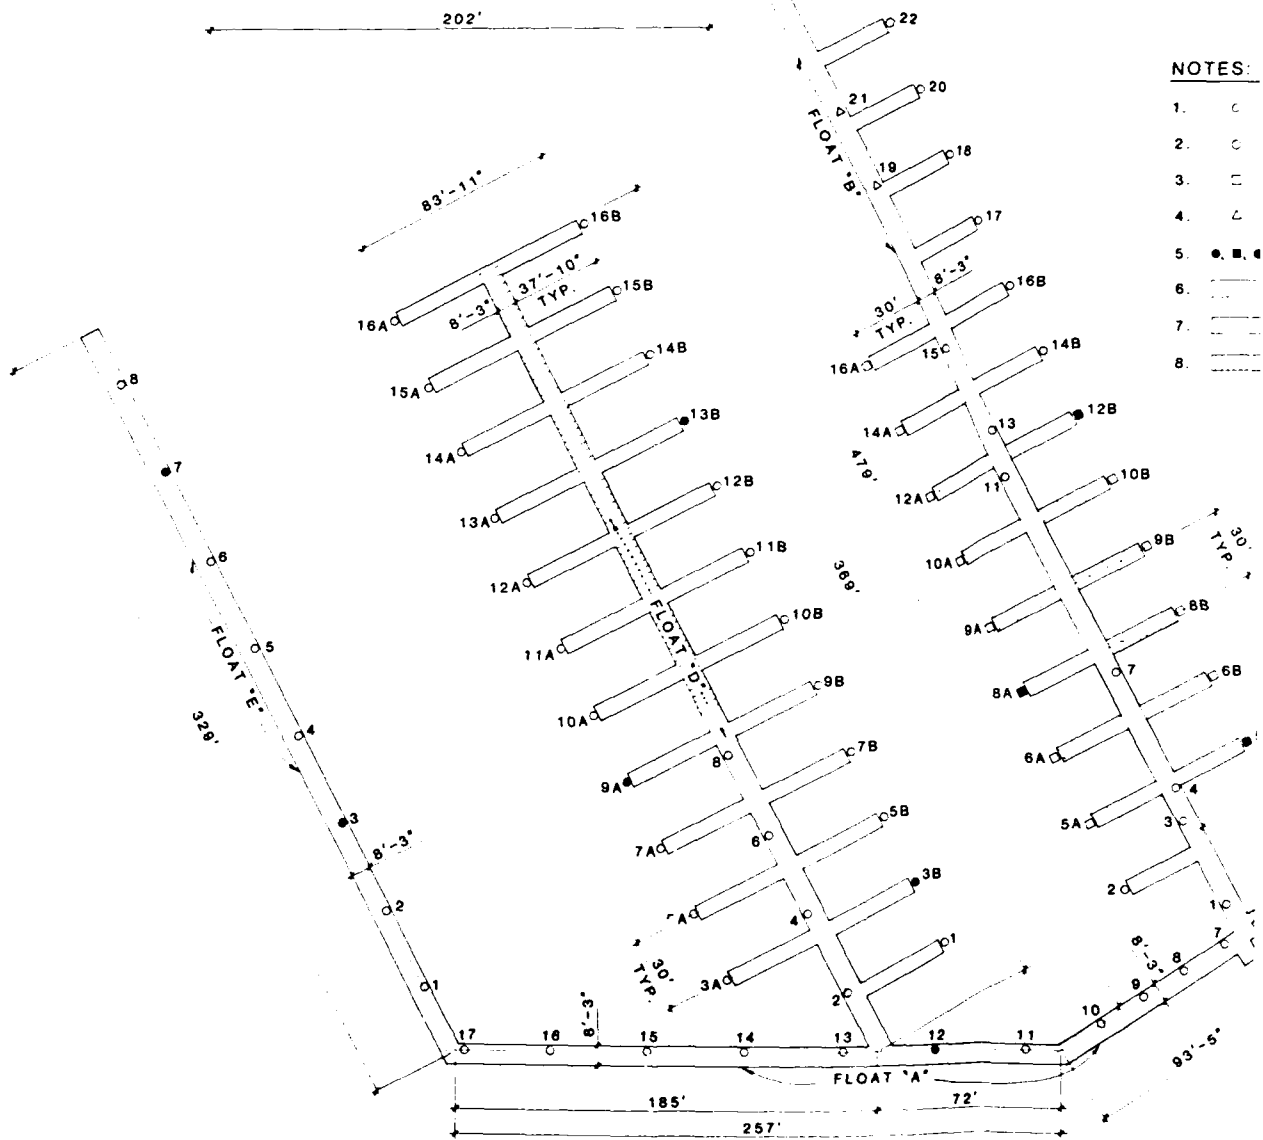
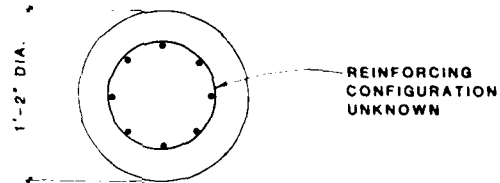
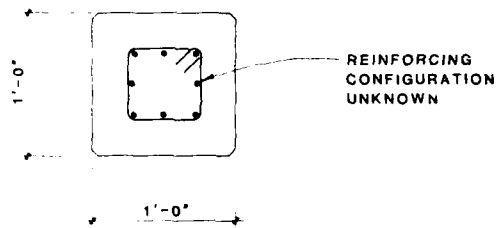
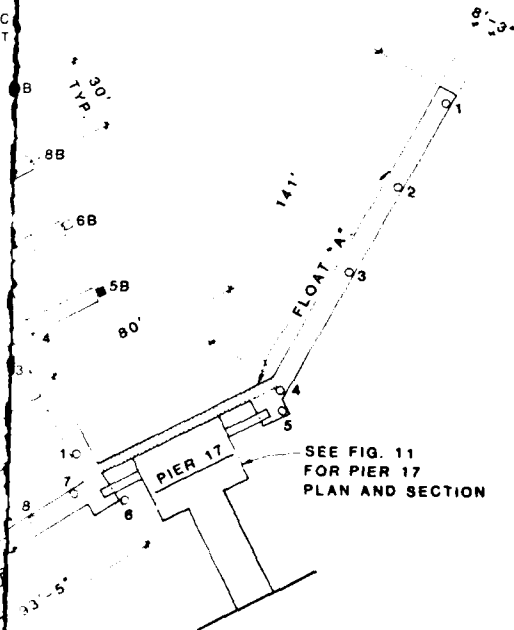
**FIG. 10**

5. Marina 1231, - At the time of this inspection, repair measures were under way to repair the deck of the floating piers and replace approximately 50 wooden piles with concrete elements. This is considered very much in order as most of the wooden piles have sustained significant damage and many are considered in bad condition.

It is recommended that the present attention to the replacement of the wooden piles of the Floating Piers be continued and that efforts be taken to cover the exposed lower sections of the Fixed Pier wooden piles.

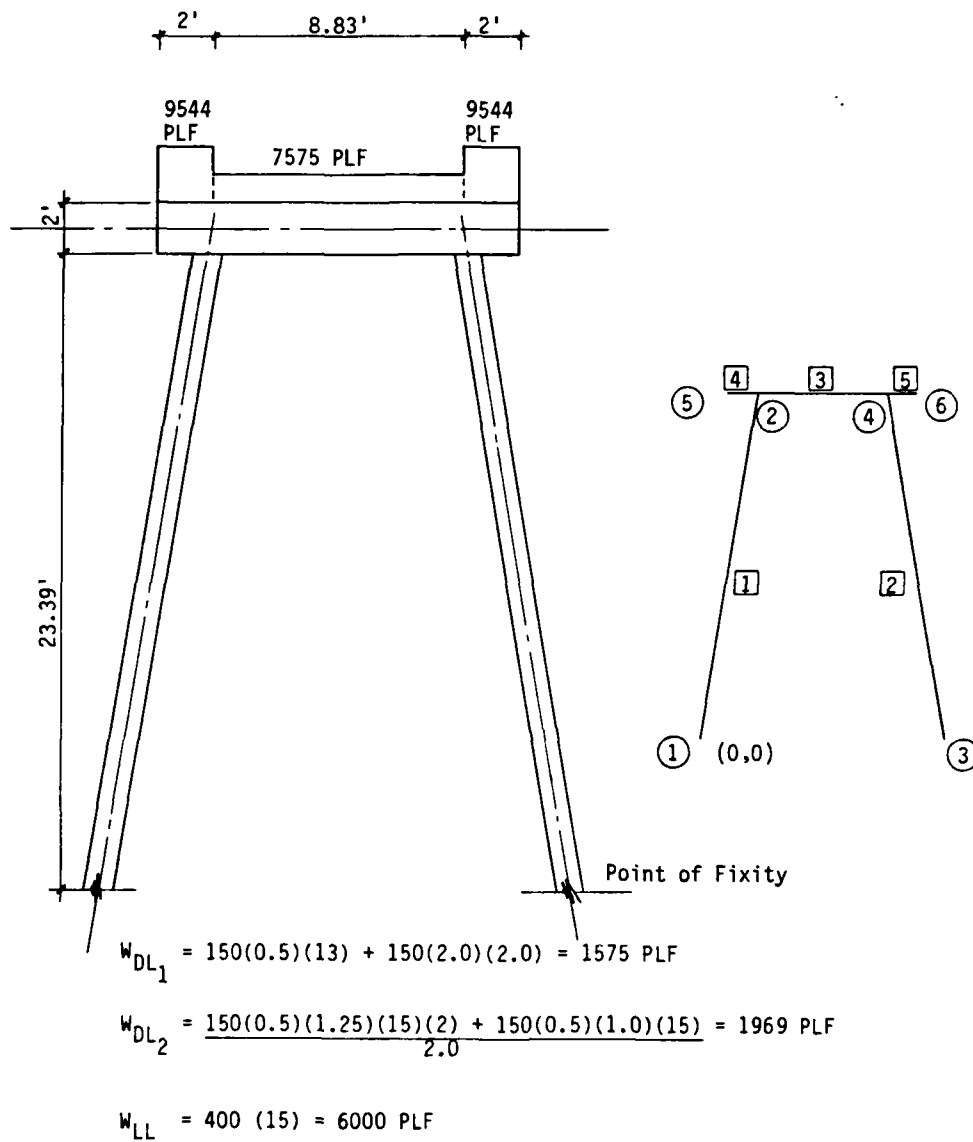
# FRAME ANALYSIS & LOADS

CALCULATE FRAME AXIAL FORCES AND MOMENTS FOR  
DEAD LOAD, LIVE LOAD AND DEAD PLUS LIVE LOADS;  
TO DETERMINE THE MAXIMUM ALLOWABLE LIVE LOAD  
CAPACITY OF THE PIER FOR THE CRITICAL PILE.

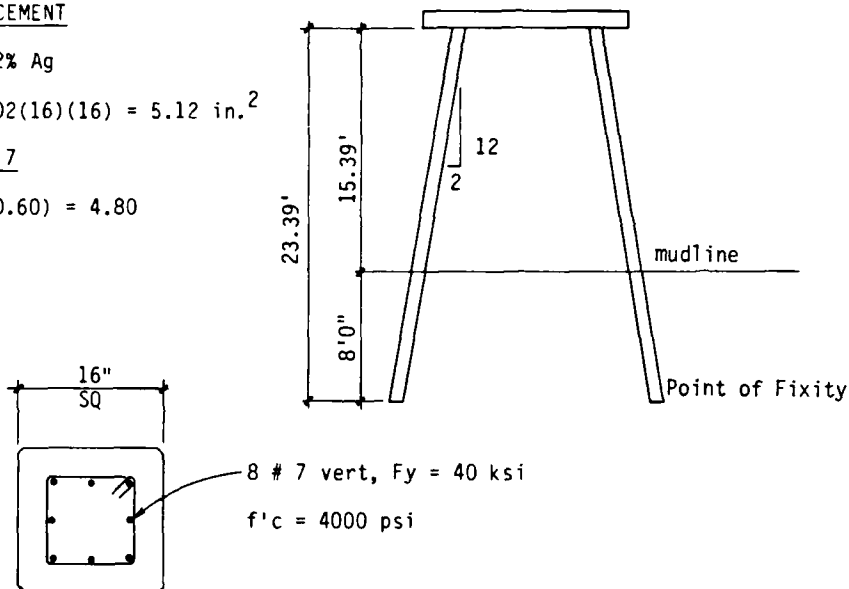
CALCULATE FRAME AXIAL FORCES AND MOMENTS FOR  
DEAD LOAD, LIVE LOAD, SEISMIC LOAD, AND DEAD  
PLUS LIVE PLUS SEISMIC LOADS; TO DETERMINE  
THE MAXIMUM ALLOWABLE LIVE LOAD CAPACITY OF  
THE PIER FOR THE PILE WITH THE AVERAGE STIFFNESS.

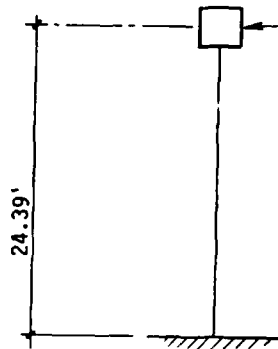
LONGITUDINAL DIRECTION

SL = 9.34 k (Total load, both piles)

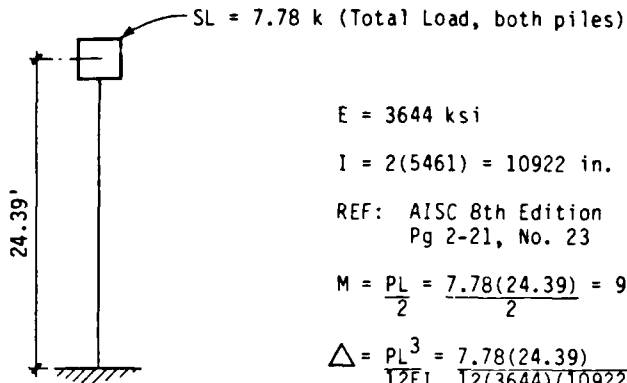
$$SL = 0.16(39.0 + 0.2(12.83)(15)(25\%)) = 7.78 \text{ kips}$$
